RAILWAY INVESTIGATION REPORT

R99H0007

DERAILMENT/COLLISION

VIA RAIL CANADA INC.

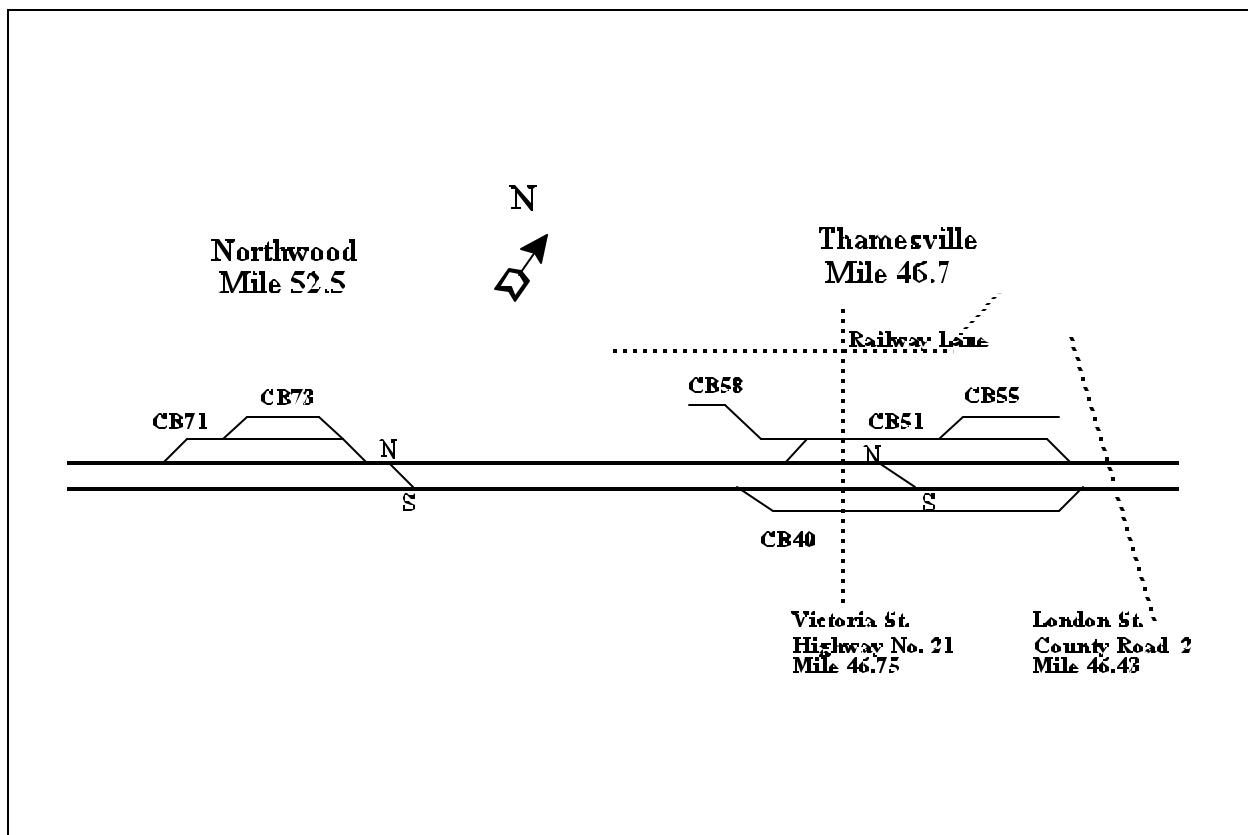
Figure 2 - Schematic of Northwood and Thamesville

Approaching Northwood, Mile 52.5, the crew on train 74 contacted the crew on train 319 and requested permission to operate between Mile 54 and Mile 46 on the north track. Train 74 was given permission by the crew on train 319 to operate within the stated mileages without restriction.
